## Case Study: Tsunagi, Japan

### First Full Mega Solar PV system in Japan

Location: Tsunagi, Japan (熊本県 津奈木町)

System Size: 1.78 MW

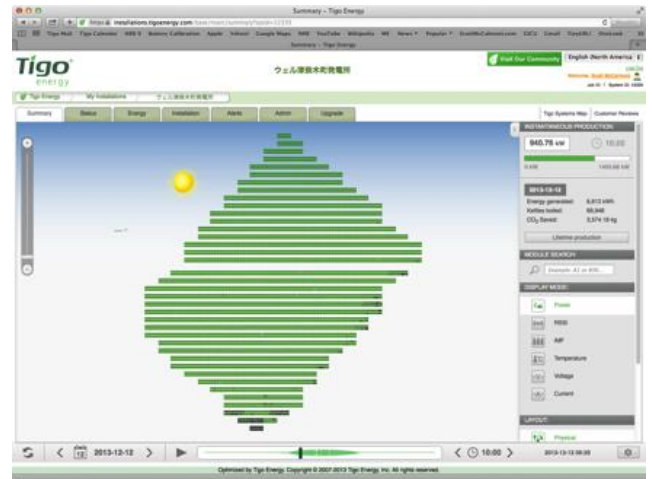
Figure 2: Installation with minor shade on the south side of the array

The system experiences a lot of shade in the winter time, as shown in Figure 2 and 3. This morning shade lasts until about 10am in the winter. Without the Tigo optimizers on the array it would be producing significantly less (5-10% lower) than a traditional array.

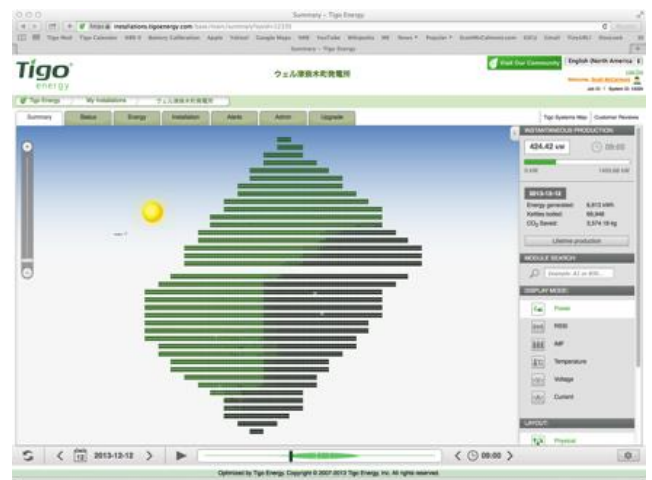
Figure 3: Heavy shading in the winter from nearby trees and power poles

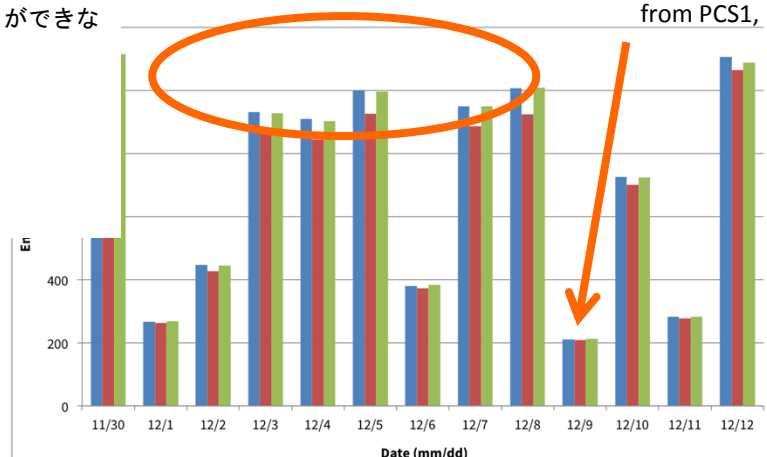
On clear days PCS2 produces less energy due to shade

Cloudy day: same energy from PCS1, PCS2, and PCS3
