# Case Study: Quickly Identifying System Problems

Kasaoka, Japan

System Size: 50 kW

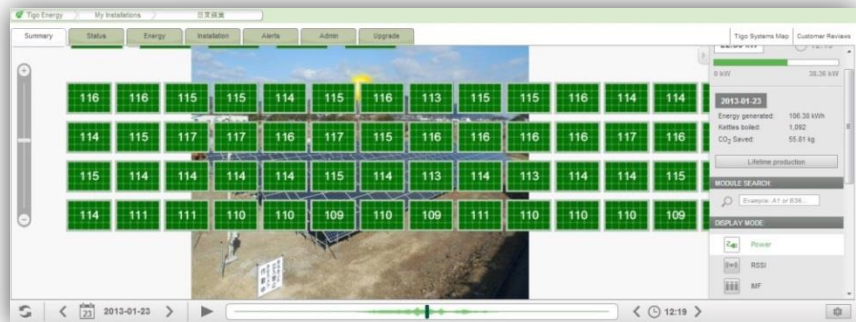
Module Q9 with normal power production at 12:19PM

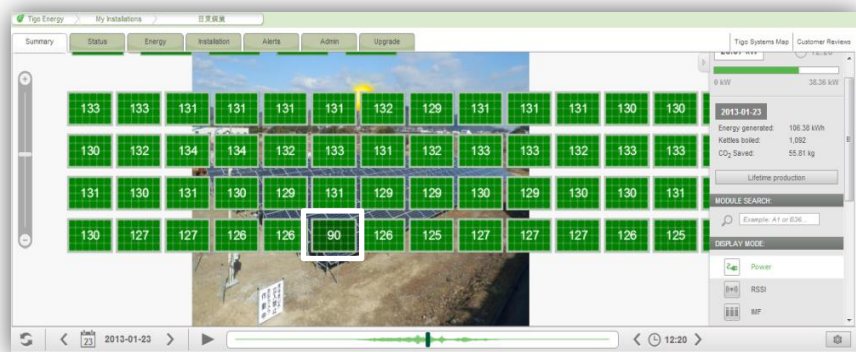
Module Q9 with bypass diode failure at 12:20PM

Using precise module-level data, Tigo Energy's support team identified two different drops in power on different dates in two different modules. On January 23, at 12:19 the power production of panel Q9 dropped by 1/3. On March 10 at 9:16 module B5 experienced a similar drop. With Tigo Energy, the problem could be identified and analyzed the minute it occurred. The drop in voltage was diagnosed as a failed diode in each module. Replacing these two diodes alone saves the customer approximately 140,000 yen over 20 years.
